Manhole Inspection Summary

Manhole # S3700_007MH

Insp Date: **9/11/08 12:24 PM**

Location Address: **2401 GREENMOUNT AVE**

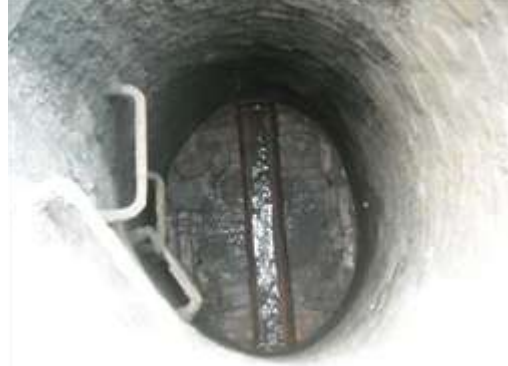
Top View

Corroded steps. Evidence of surcharge - Bench debris.

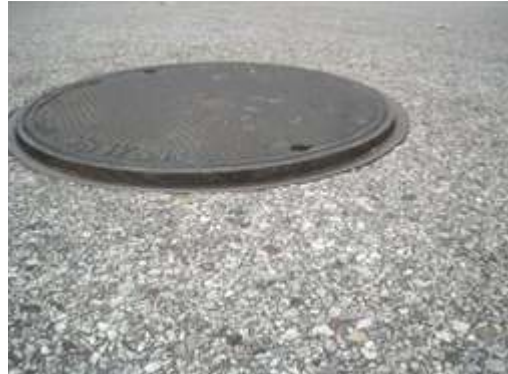
New lid

The lid does not fit correctly.

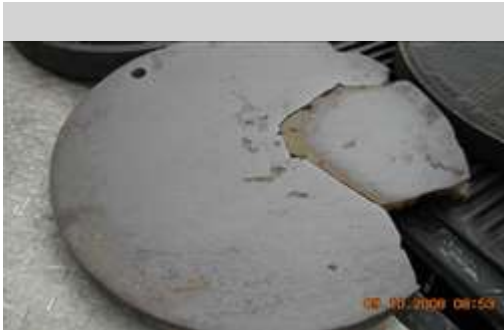
Broke lid

Type: **Sanitary** Condition: **Cracked** Cover Material: **Cast Iron**

Comments **REI/DRAYCO VISIT 9/10/08 BROKE AND REPLACED LID**

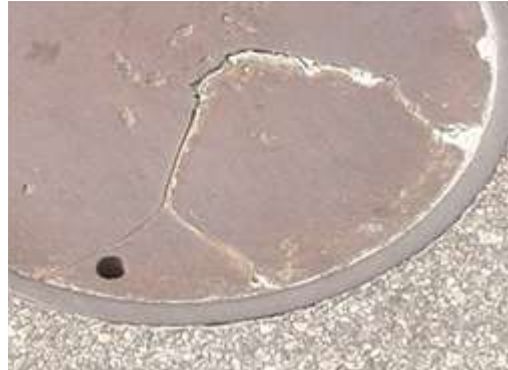
Defect

Cracked lid (was replaced)

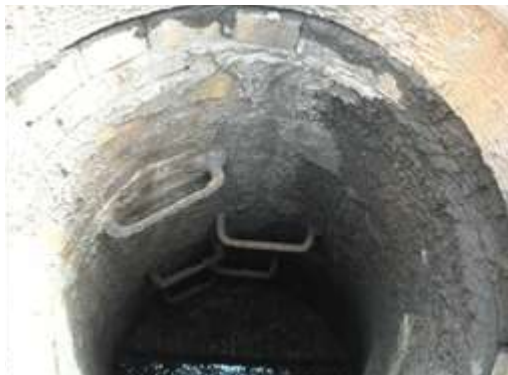
Defect

Frame Offset: **0** (in.) Condition: ☐ Sound ☐ Cracked ☒ **Leaks**

Condition: ☐ Sound ☐ Cracked ☐ Root Intrusion ☐ Loose Brick ☒ **Deteriorated**

Infiltration: ☐ None ☒ **Joint** ☐ Cracks ☒ **Mortar** ☐ Roots ☐ Wall

Frame leaks. Adjusttent deterioration and infiltration.

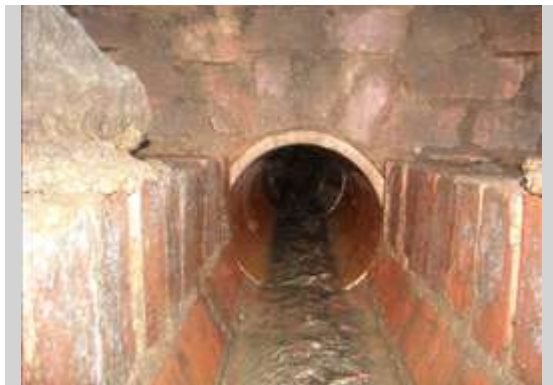
Pipe Out @ 12 O'Clock

8 in. Circular Gravity Sewer

Pipe Material: **Clay** ☐ Pipe Lined

Invert Depth: **9.70** (ft.) Flow Characteristics: **Slow**

Infiltration: **None** Pipe Seal Cond: **Unknown**

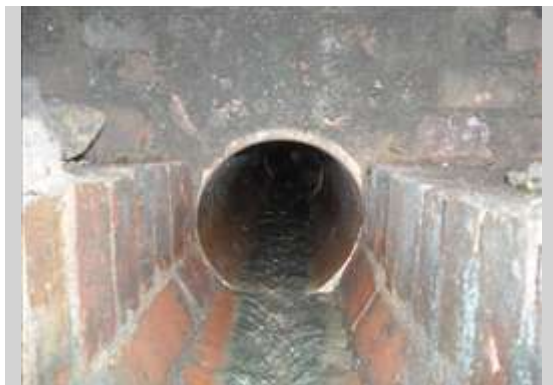
Pipe In @ 6 O'Clock

8 in. Circular Gravity Sewer

Pipe Material: **Clay** ☐ Pipe Lined

Invert Depth: **9.65** (ft.) Flow Characteristics: **Slow**

Infiltration: **None** Pipe Seal Cond: **Unknown**
